ICFA Blast Demo

FPED - Force Protection Exposition and Demonstration
a bi-annual Military and Homeland Security exposition and trade show

In March 2005, at the invitation of the ICFA, Marc Philippe and Bill Naegeli participated in a “Blast” Demonstration for the Force Protection Exposition and Demo, a bi-annual Military and Homeland Security exposition and trade show held at Quantico Marine Base in Virginia, with 9 other ICF manufacturers. The IntegraSpec structure was quickly erected and poured without incident. (Which could not be said of all ICFs)

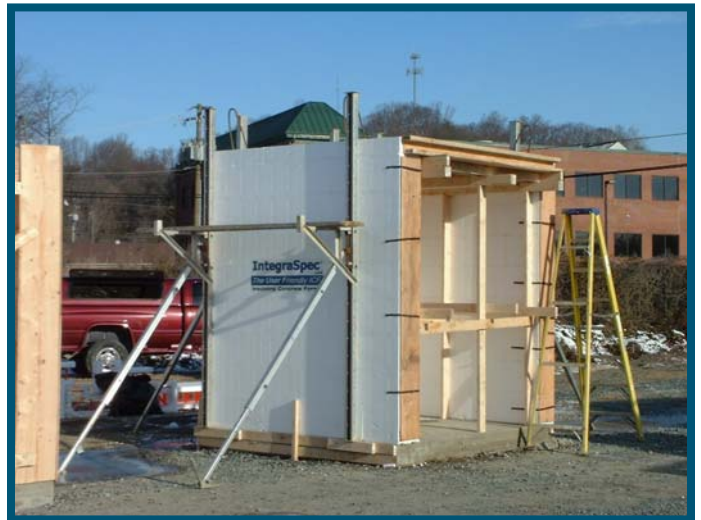
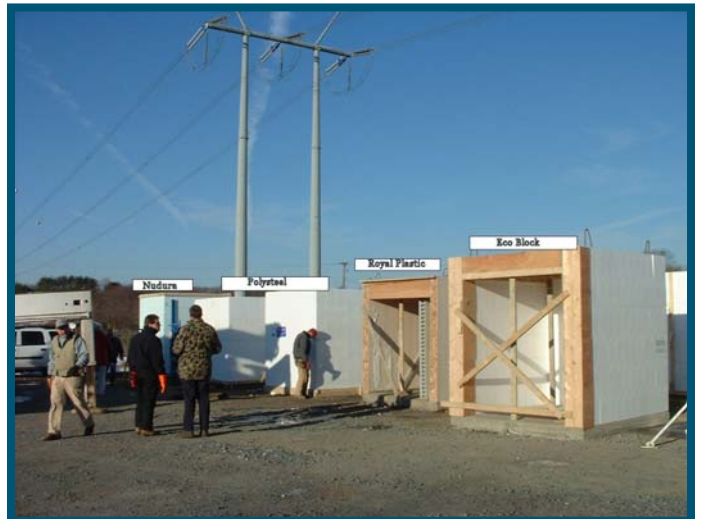
◆◆◆ ICF Wall Setup ◆◆◆

Form & pour the slab. Received the concrete only at 3:00 in the afternoon. While waiting for concrete, the platform for the overhead slab was prepared.

Formed the walls in heavy rain & snow then installed decking cover the top with a tarp & called by 11:10 a.m., with approximately 1 hour of work remaining to finish the box.

Finished & poured our box. While we were on site, ECO Block, IntegraSpec, Nudura & TF Form were also poured.
