# ICFA Blast Demo

FPED - Force Protection Exposition and Demonstration  
a bi-annual Military and Homeland Security exposition and trade show

## ◆◆◆ ICF Wall Setup ◆◆◆

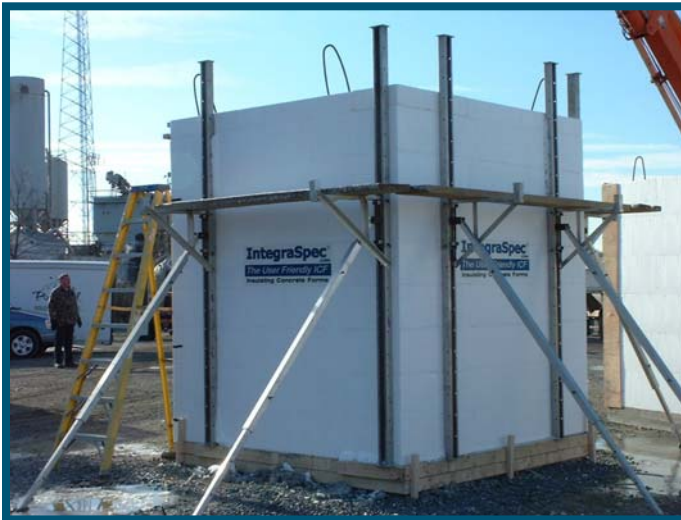
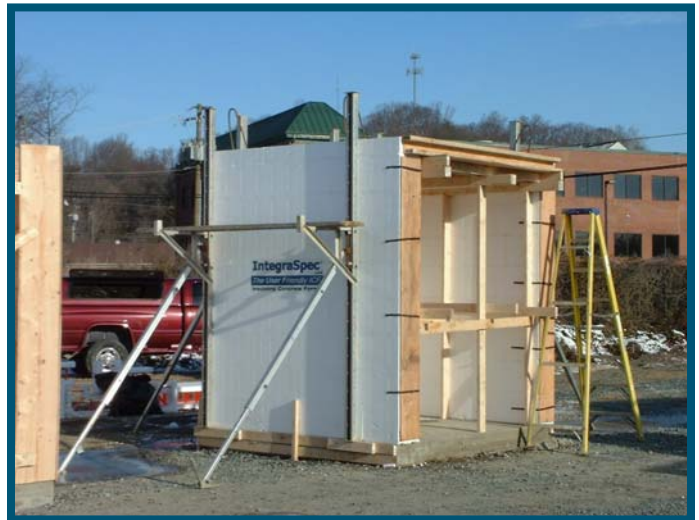
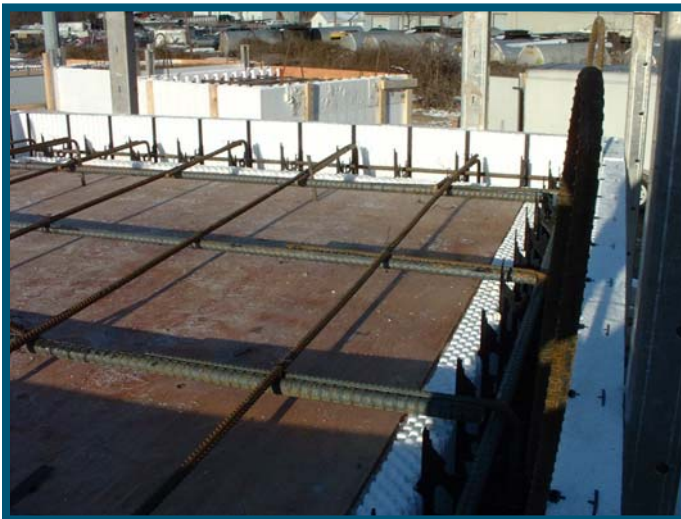
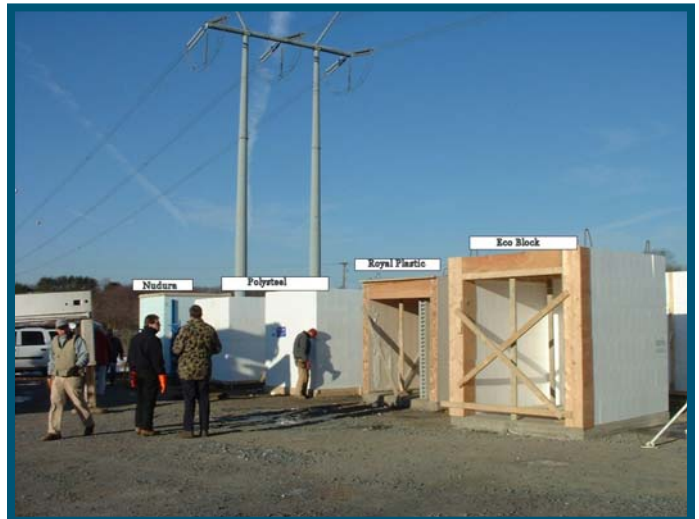
Form & pour the slab. Received the concrete only at 3:00 in the afternoon. While waiting for concrete, the platform for the overhead slab was prepared.

Formed the walls in heavy rain & snow then installed decking cover the top with a tarp & called by 11:10 a.m., with approximately 1 hour of work remaining to finish the box.

Finished & poured our box. While we were on site, ECO Block, IntegraSpec, Nudura & TF Form were also poured.

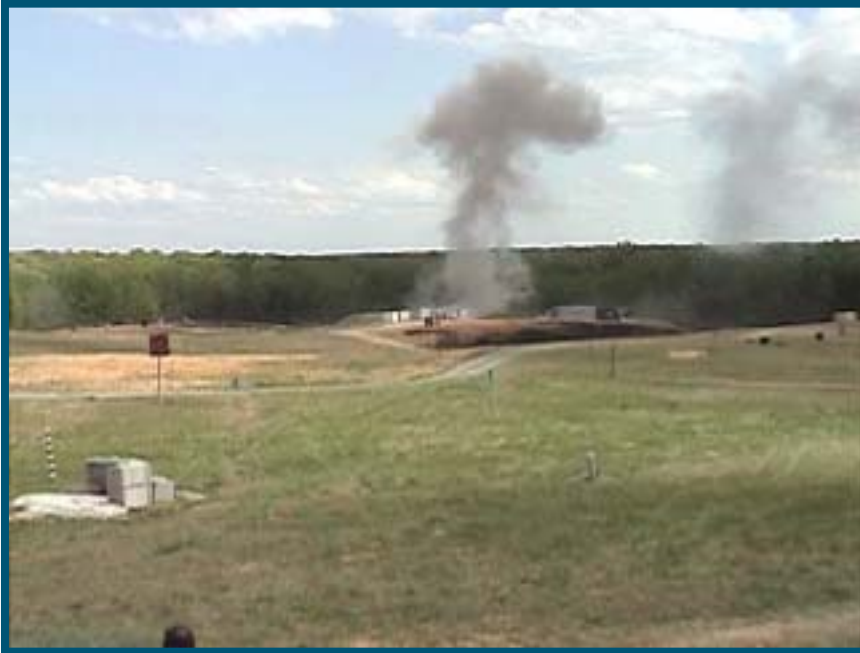
Participants could witness the blasting from a safe distance

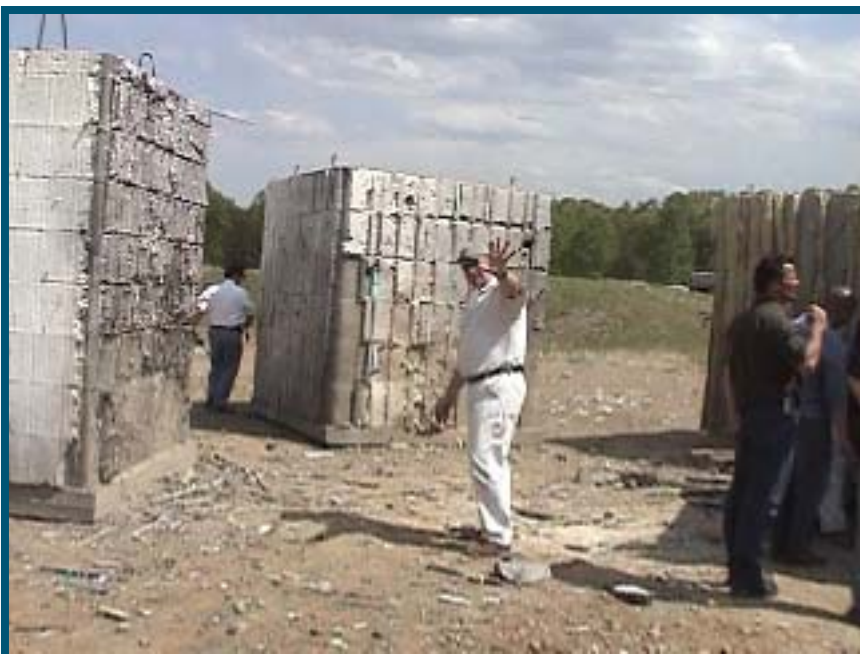
**IntegraSpec** performed to the highest standards. Our structure had very little damage. (Left) **IntegraSpec’s** wall remained intact without holes, corner failures or other structural failures. Our strength could be contributed to solid consolidation with our easy flow through web design and the continuous contact of EPS to the concrete face facilitated by our interior dovetail grooves. Here’s one for the good guys!

IntegraSpec’s box (on the left) after the blast test

In April 2005, our team, along with Mark Ross of ART Inc. witnessed a spectacular display of fortitude. Each ICF structure was directly hit with 50 lbs. of TNT, from a distance of approx. 6 feet. US Marine Corp detonation team conducted, supervised, and recorded details of the performance of each ICF structure. Evaluations were not published, however, to negate any focus on competition.
